Inspection Report

Property Address:
3 Elderberry Ct
Durham NC 27703

AA Home Inspections LLC

Date: 2/17/2010	Time:	Report ID:
Property: 3 Elderberry Ct Durham NC 27703	Customer: Jonathan Bartel	Real Estate Professional: Christine Danko

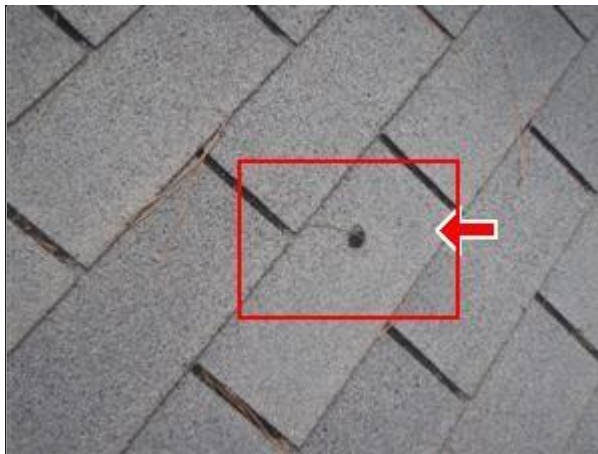
3.0 Picture 1

A roof shingle is damaged at the rear elevation. This damage should be repaired or replaced. A general home repair company needs to make the appropriate repair..

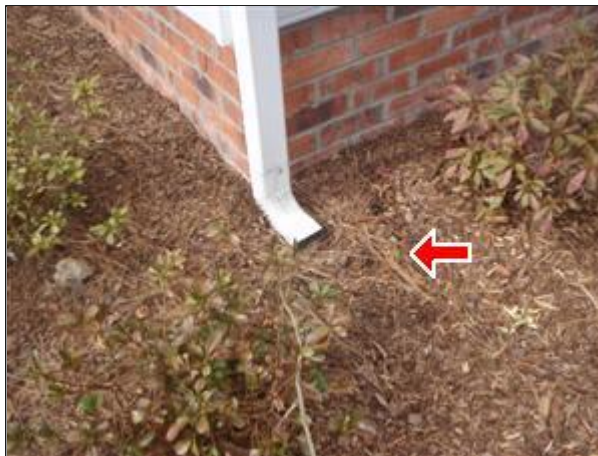
3.2 Picture 1

The downspout needs a splash-block at the left front.

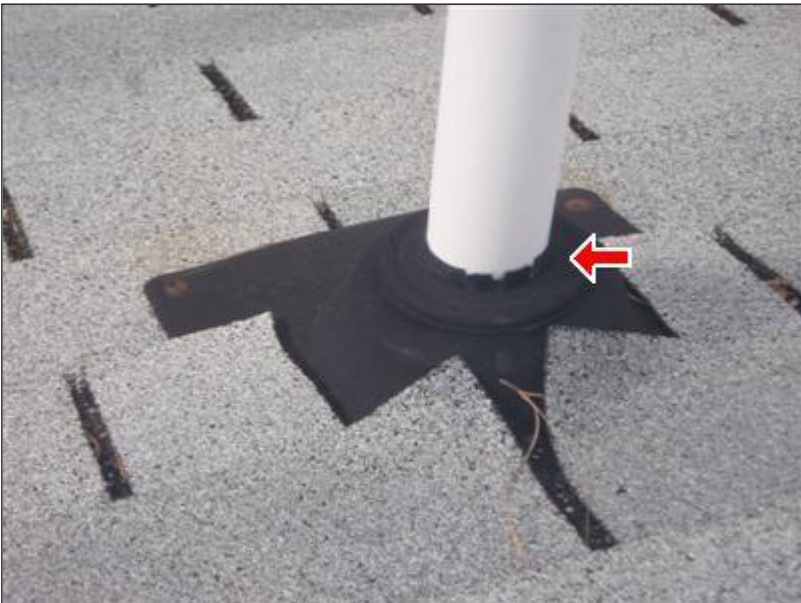
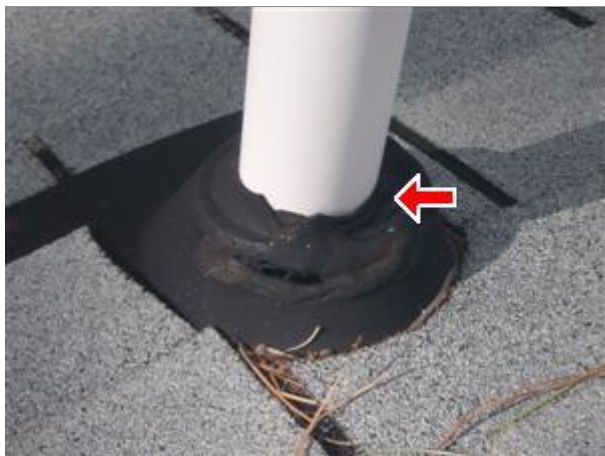
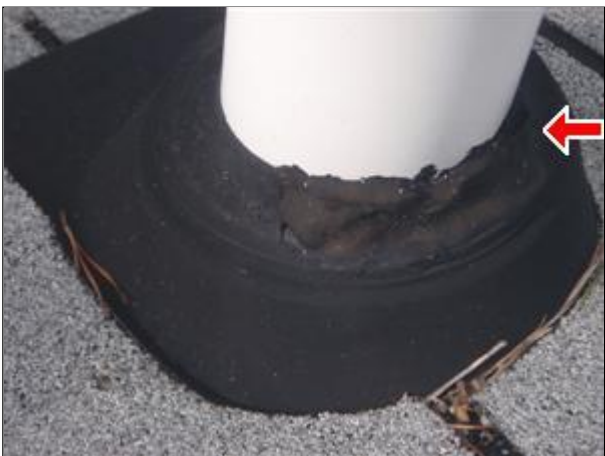
🏠 The sewer vent flange's are split. This can allow water infiltration into the attic. A qualified roofing contractor needs to replace.

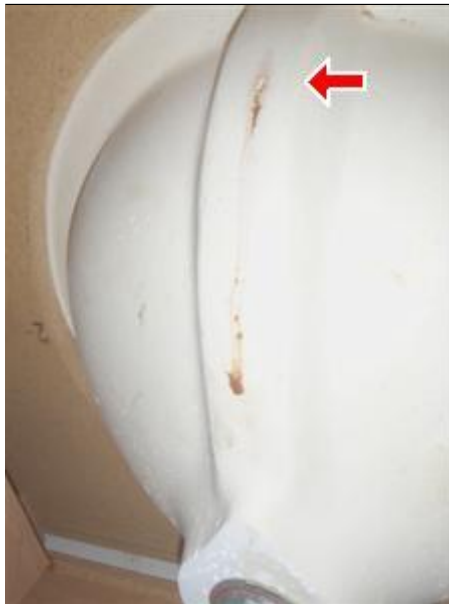
4.0 Picture 1

(1) The sink in the hall bath leaks at the overflow track underneath the sink. The leak only occurs when the sink has been filled with water. The hole needs to be filled with a waterproof filler.

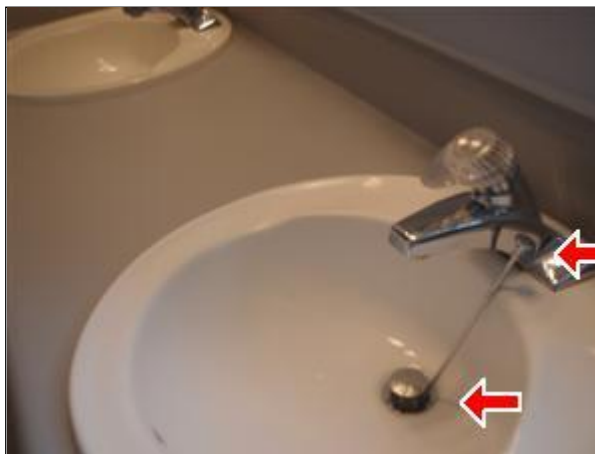
4.0 Picture 2

(2) The stopper mechanism in the master bath sink does not function. A licensed plumbing contractor needs to repair as needed.

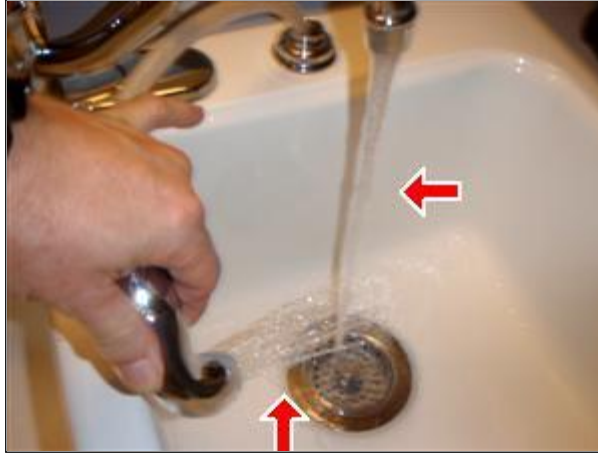
4.1 Picture 1

- 🏠 (1) The diverter in the kitchen sink faucet does not stop the water flow when the sprayer handle is engaged. A licensed plumbing contractor needs to make the appropriate repairs.

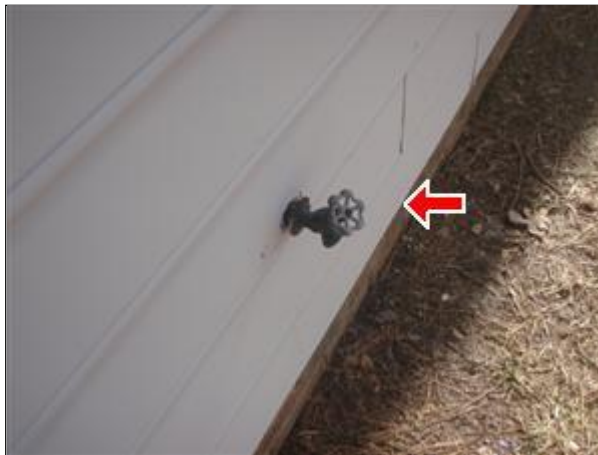
4.1 Picture 2

- 🏠 (2) The hose bib is loose, and needs securing to the wall at the right end. Repairs are needed. A licensed plumbing contractor needs to repair as needed.

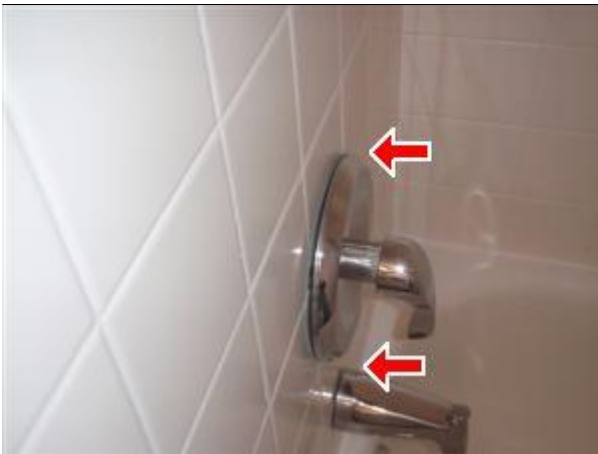
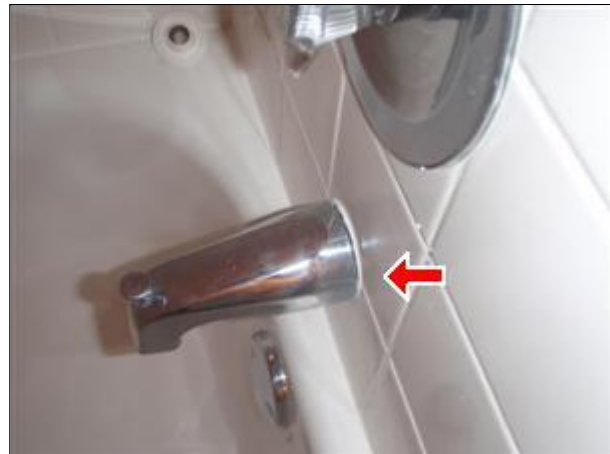
- 🏠 (3) The tub spout and control lever escutcheon is loose at the both bathrooms. Water can leak behind the wall at this point. These need to be sealed to the wall. A licensed plumbing contractor needs to repair as needed.

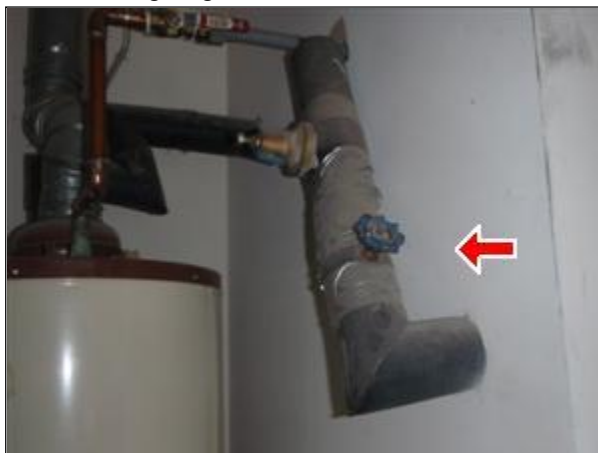
4.3 Picture 1

The main shut off is the knob located in the garage.

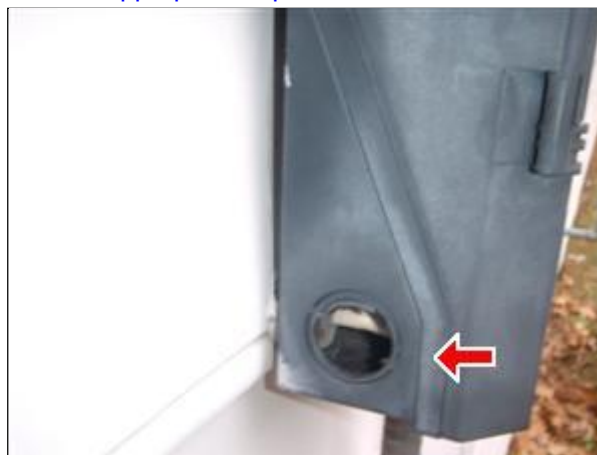
5.1 Picture 1

The AC panel box is missing a knockout. Electrical issues are considered a hazard until repaired. A licensed electrical contractor needs to make the appropriate repairs..

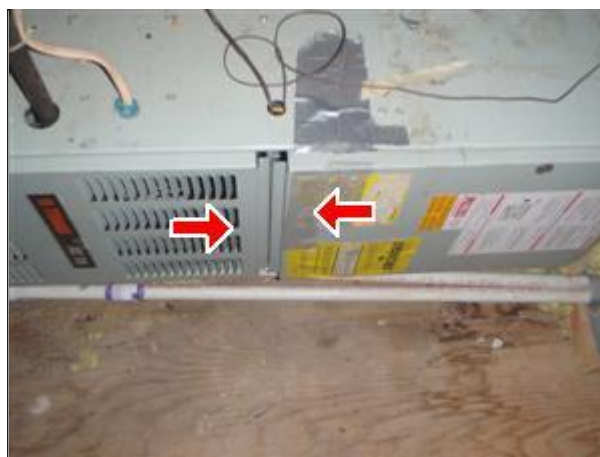
6.0 Picture 1

The doors on the front of the furnace in the attic do not latch completely. This can allow the doors to open slightly causing the furnace to shut off. The doors need to be secured. A licensed HVAC contractor needs to make the appropriate repair.

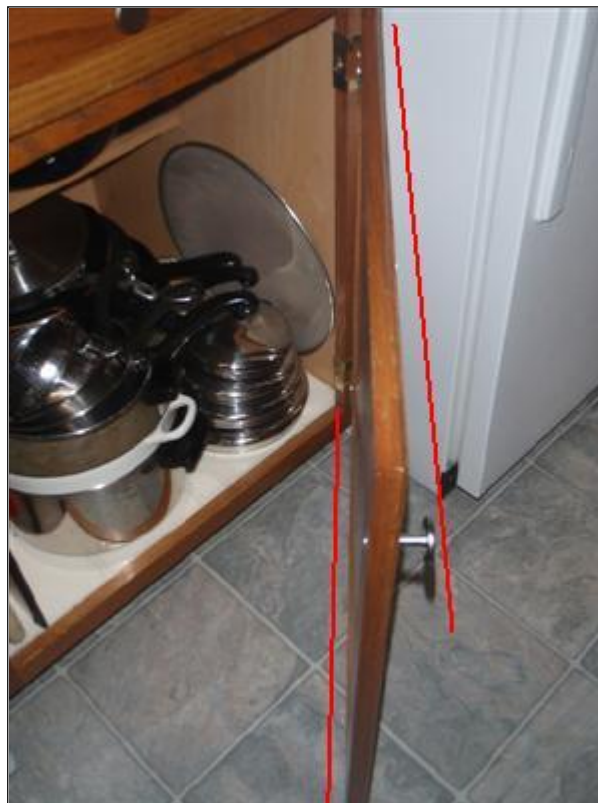
8.4 Picture 1

The cabinet door is warped (right of stove). This is a cosmetic issue for your information. Recommend repair or replace as necessary.

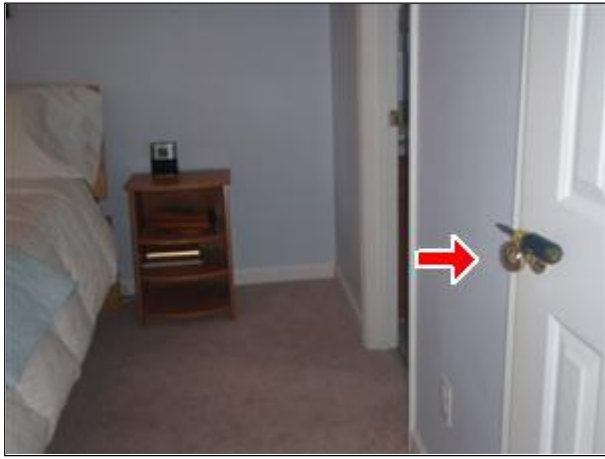
8.5 Picture 1

The closet door needs strike and latch adjustment to shut tight at the Master Bedroom. A general home repair company needs to make the appropriate repair..

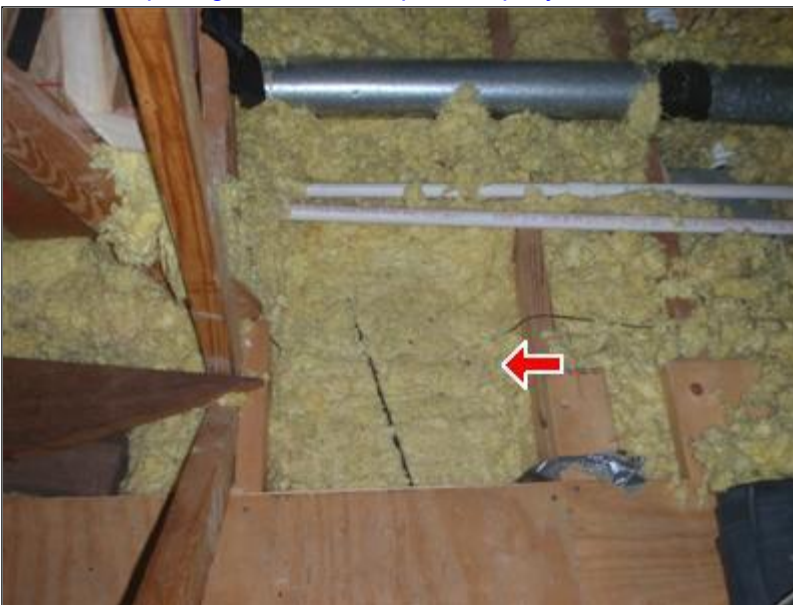
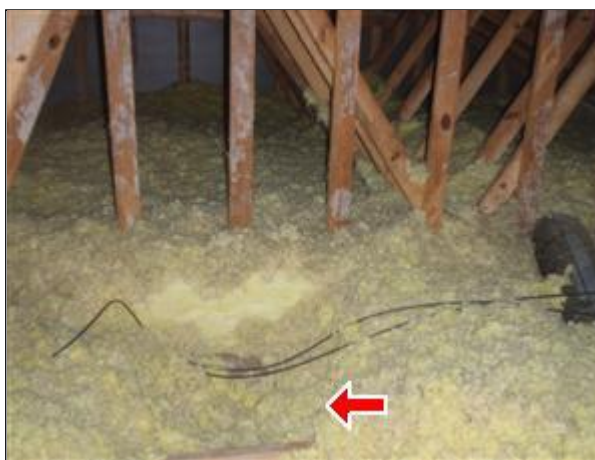
Several areas of loose fill insulation in the attic have been compacted. This can cause energy loss in these areas. This insulation needs to be fluffed up. A general home repair company needs to fluff as needed.

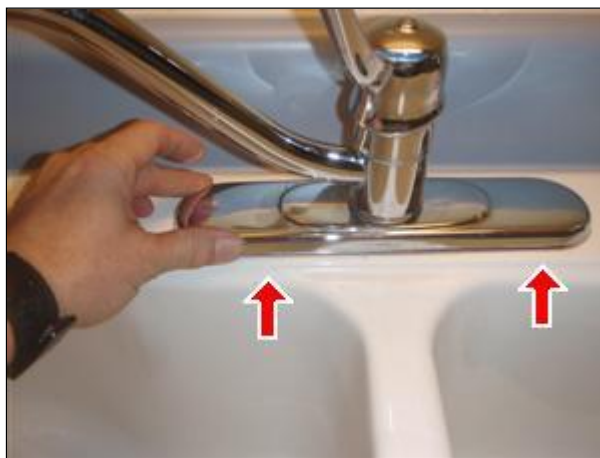
10.10 Picture 1

(1) The diverter in the kitchen sink faucet does not stop the water flow when the sprayer handle is engaged. A licensed plumbing contractor needs to make the appropriate repairs.

(2) The base of the faucet is loose and needs to be tightened.

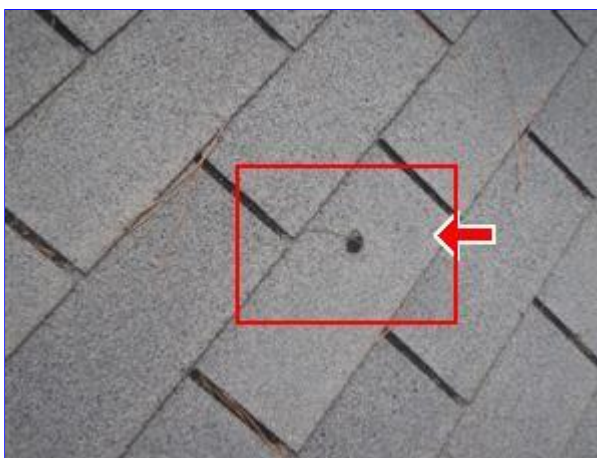
3.0 Picture 1

A roof shingle is damaged at the rear elevation. This damage should be repaired or replaced. A general home repair company needs to make the appropriate repair..

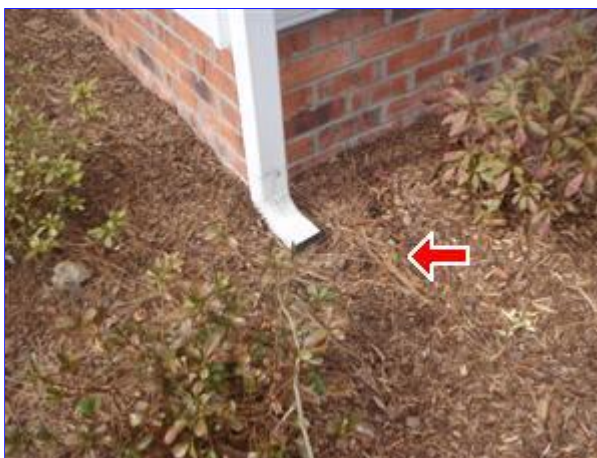
3.2 Picture 1

The downspout needs a splash-block at the left front.

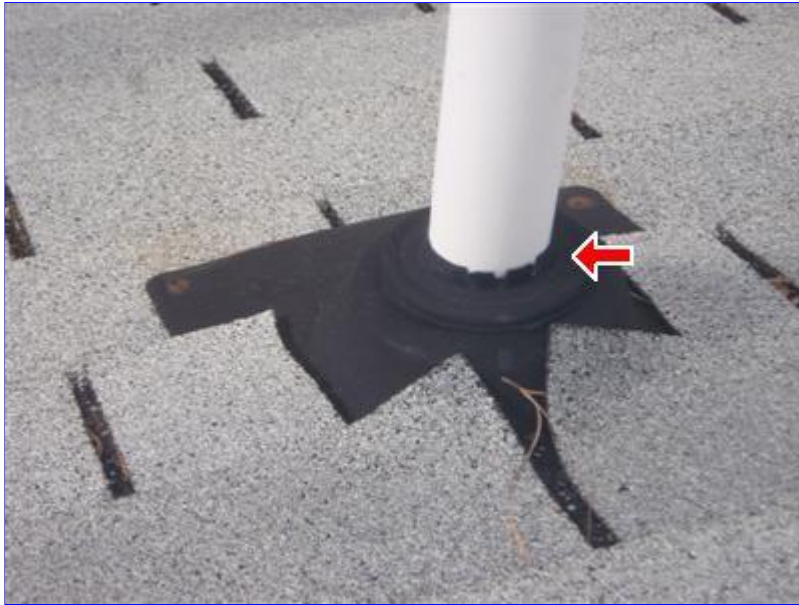
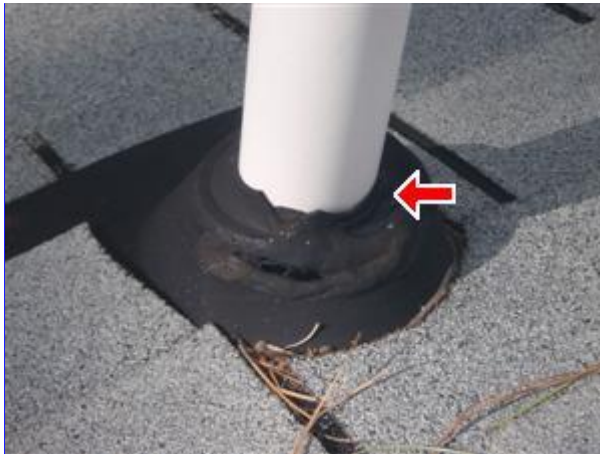
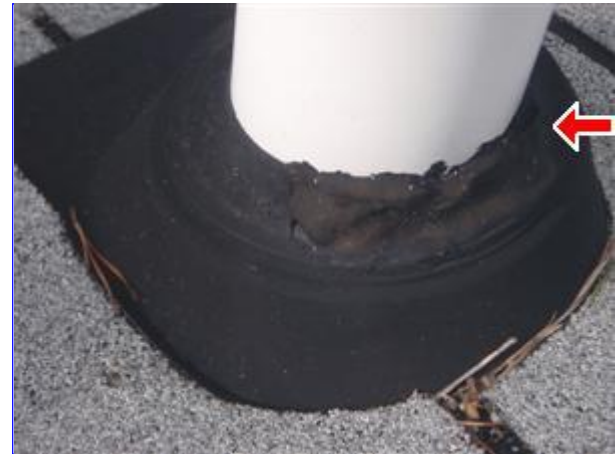
The sewer vent flange's are split. This can allow water infiltration into the attic. A qualified roofing contractor needs to replace.

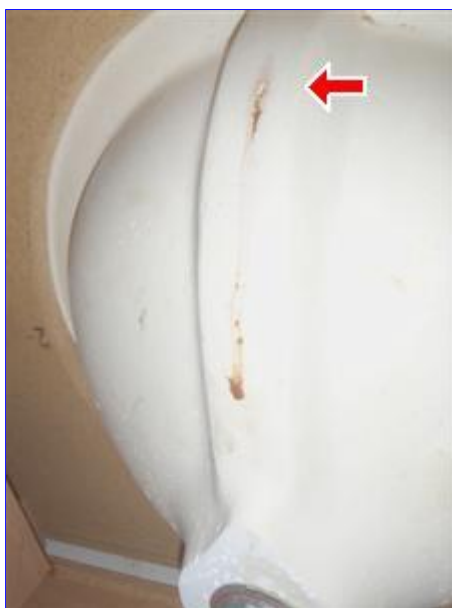
4.0 Picture 1

(1) The sink in the hall bath leaks at the overflow track underneath the sink. The leak only occurs when the sink has been filled with water. The hole needs to be filled with a waterproof filler.

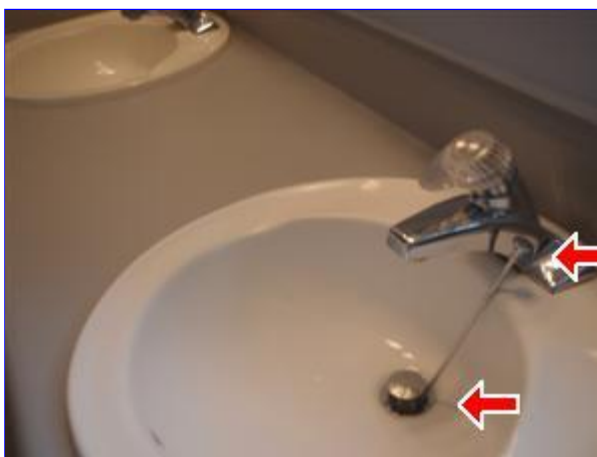
4.0 Picture 2

(2) The stopper mechanism in the master bath sink does not function. A licensed plumbing contractor needs to repair as needed.

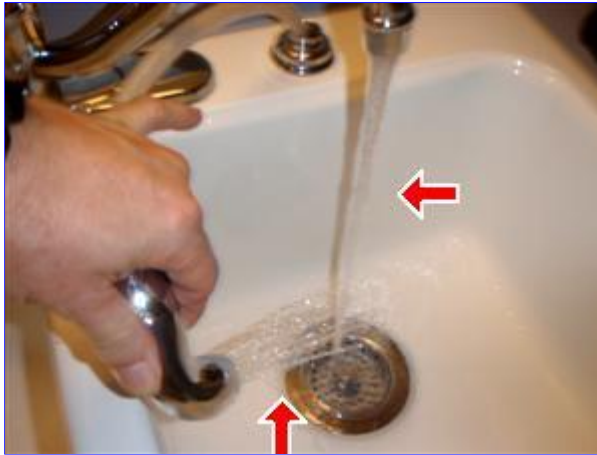
4.1 Picture 1

(1) The diverter in the kitchen sink faucet does not stop the water flow when the sprayer handle is engaged. A licensed plumbing contractor needs to make the appropriate repairs.

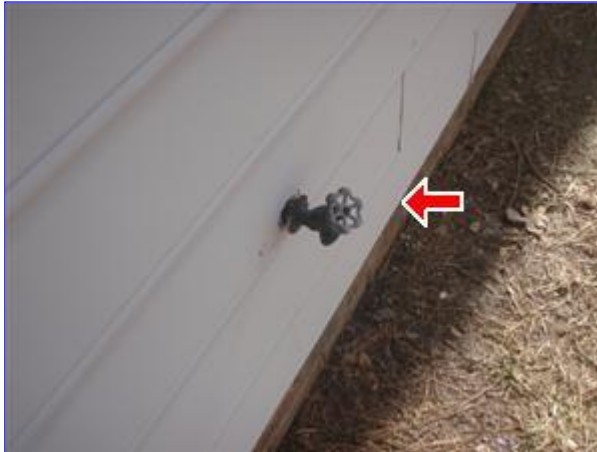
4.1 Picture 2

(2) The hose bib is loose, and needs securing to the wall at the right end. Repairs are needed. A licensed plumbing contractor needs to repair as needed.

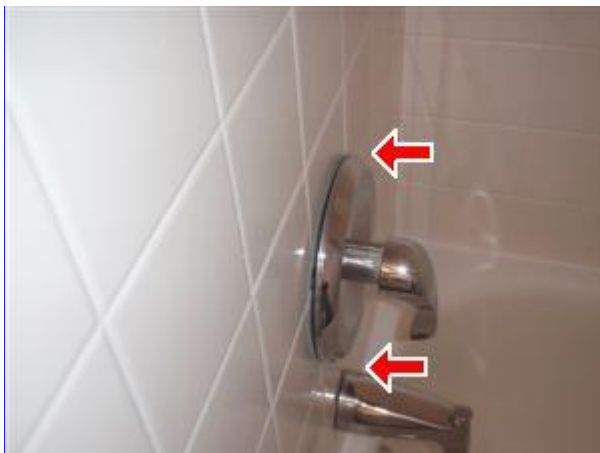
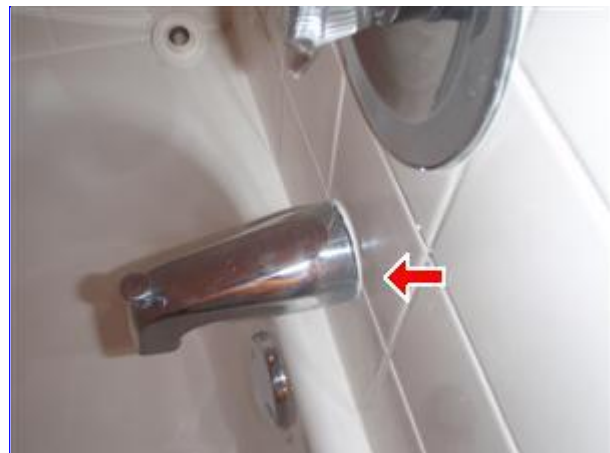
(3) The tub spout and control lever escutcheon is loose at the both bathrooms. Water can leak behind the wall at this point. These need to be sealed to the wall. A licensed plumbing contractor needs to repair as needed.

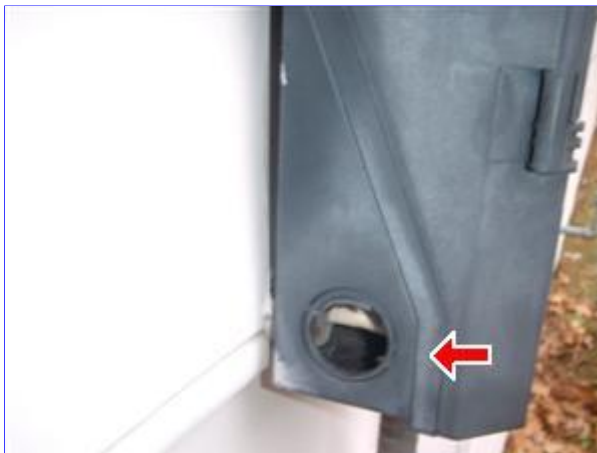
5.1 Picture 1

The AC panel box is missing a knockout. Electrical issues are considered a hazard until repaired. A licensed electrical contractor needs to make the appropriate repairs..

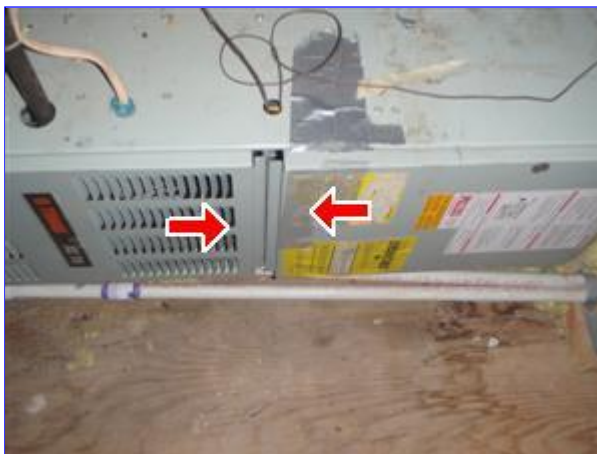
6.0 Picture 1

The doors on the front of the furnace in the attic do not latch completely. This can allow the doors to open slightly causing the furnace to shut off. The doors need to be secured. A licensed HVAC contractor needs to make the appropriate repair.

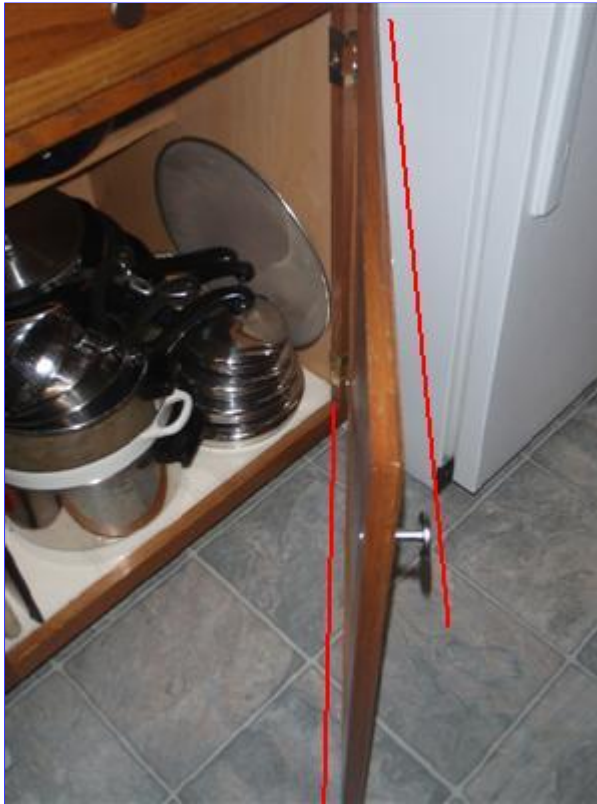
8.4 Picture 1

- 🏠 The cabinet door is warped (right of stove). This is a cosmetic issue for your information. Recommend repair or replace as necessary.

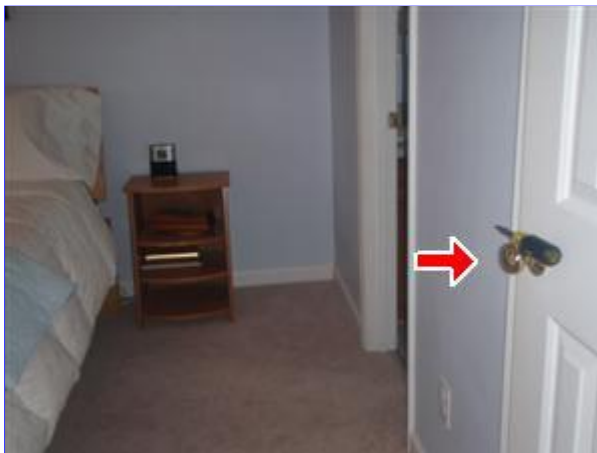
8.5 Picture 1

- 🏠 The closet door needs strike and latch adjustment to shut tight at the Master Bedroom. A general home repair company needs to make the appropriate repair..

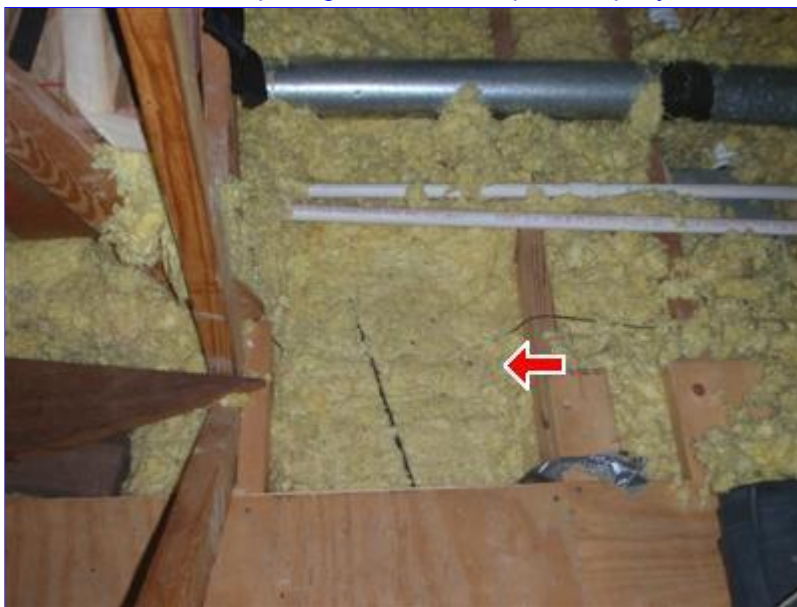
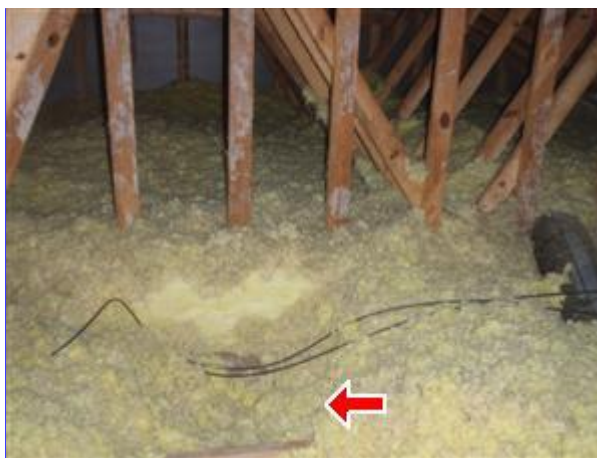
- Several areas of loose fill insulation in the attic have been compacted. This can cause energy loss in these areas. This insulation needs to be fluffed up. A general home repair company needs to fluff as needed.

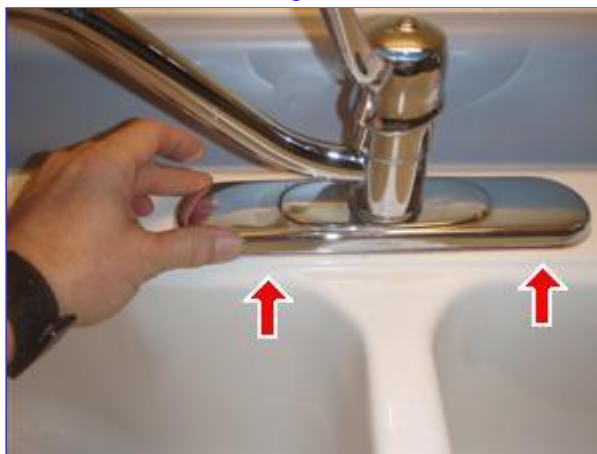
10.10 Picture 1

- 🏠 (1) The diverter in the kitchen sink faucet does not stop the water flow when the sprayer handle is engaged. A licensed plumbing contractor needs to make the appropriate repairs.
- 🏠 (2) The base of the faucet is loose and needs to be tightened.
